The Well at Beara in Devon:

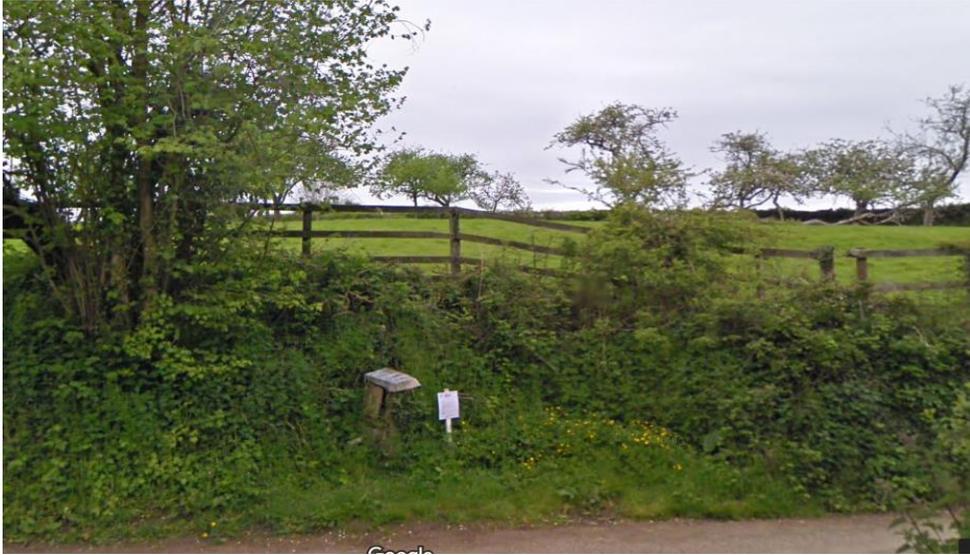
When the public Mains Water Supply was installed in the little hamlet of Beara in South Devon, the Well that supplied its water since 1886 from a small lay-by became obsolete. Over the resulting years the Well Head and its lower woodwork had slowly disappeared under the compost of the surrounding fauna and leaves.

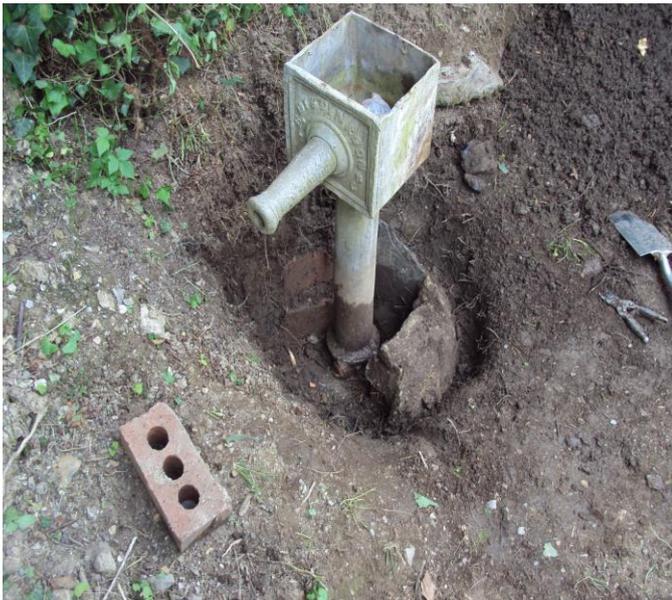
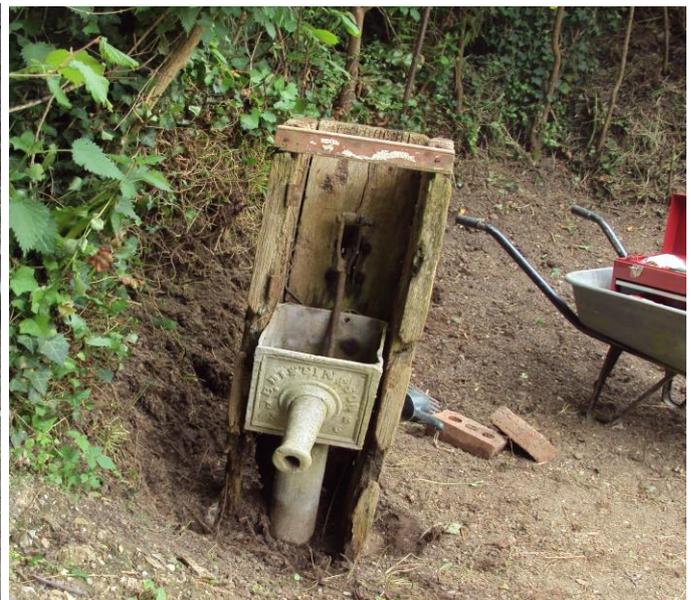
In July of 2018, I decided to “have-a-go” at restoring the Well. I began the process of uncovering the hidden parts of its wooden frame. I was amazed at the amount of soil that had built-up over the years, approximately 25 cm in depth. I soon arrived at some brickwork surrounding the base of the Well’s rather rotted oak frame.

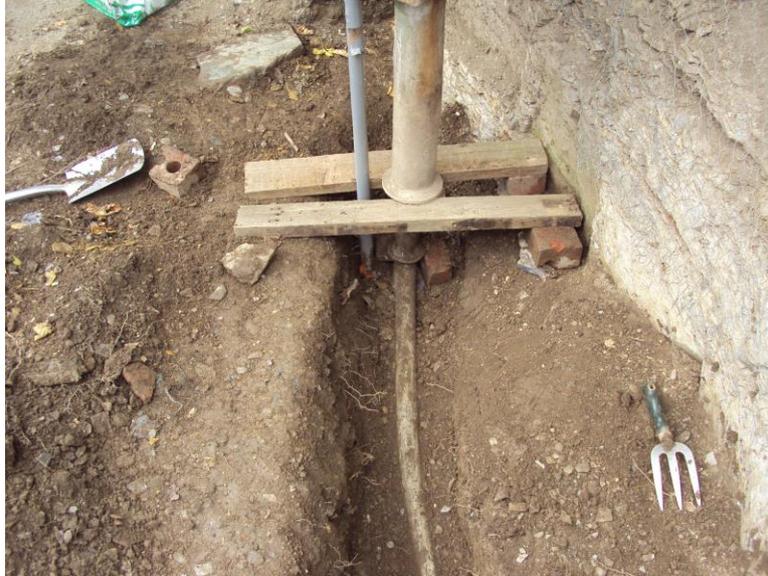
After clearing-out all the old bricks, some concrete and the rotten frame I discovered the pump Head and Barrel could be rocked from side to side. I feared the worst... had the pipe had broken underground? I began to dig-out the surrounding soil and to my surprise the Barrel was joined to a 15cm long tapered extension that turned thru 90 degrees and headed-off towards the stone wall. I dug a meter long trench following the line of the pipe but it started to head into the banking so I stopped, supported the Barrel / Head in a vertical position and filled it in. My neighbours and I were perplexed as to why this particular horizontal layout and not a vertical one.

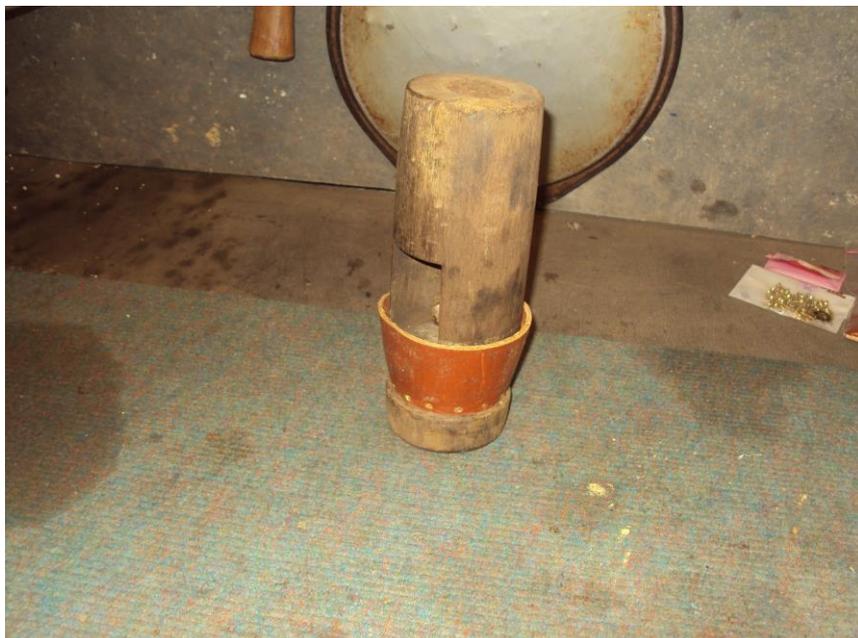
The next step was the so-called "bucket". It took a while to extract this component as the Barrel was stuffed with years of leaves, twigs and mud. When it finally came out I discovered that the so-called "cup" was created from a piece of bicycle tire rubber (yellow stripe gave it away) instead of the leather I was expecting. The leather Clack Valve had also been replaced with a flap of heavy rubber but worked ok so was left as is. A piece of 3.5mm leather was purchased and cut to shape for the Cup and mounted using copper nails.

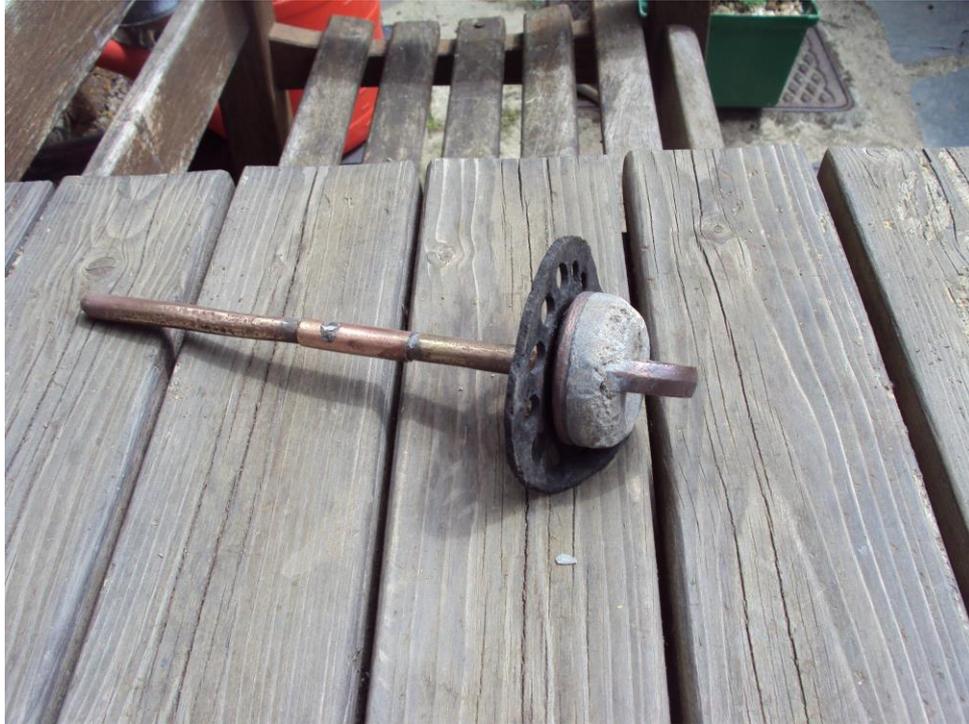
Next was the Spindle Valve which took a while to extract as well. I had to use a long piece of heavy gauge copper ground wire, hooked on one end, to find the "handle" of the Spindle valve. After a few choice words and a lot of fiddling I managed to get it hooked. Then I began twisting it back and forth to try and release it from the valve. It finally relented and came loose so it could be extracted. Once removed it became apparent that at some point in its life it had been converted from a "short" to a "long" version using a length of brass rod and split copper tubing.

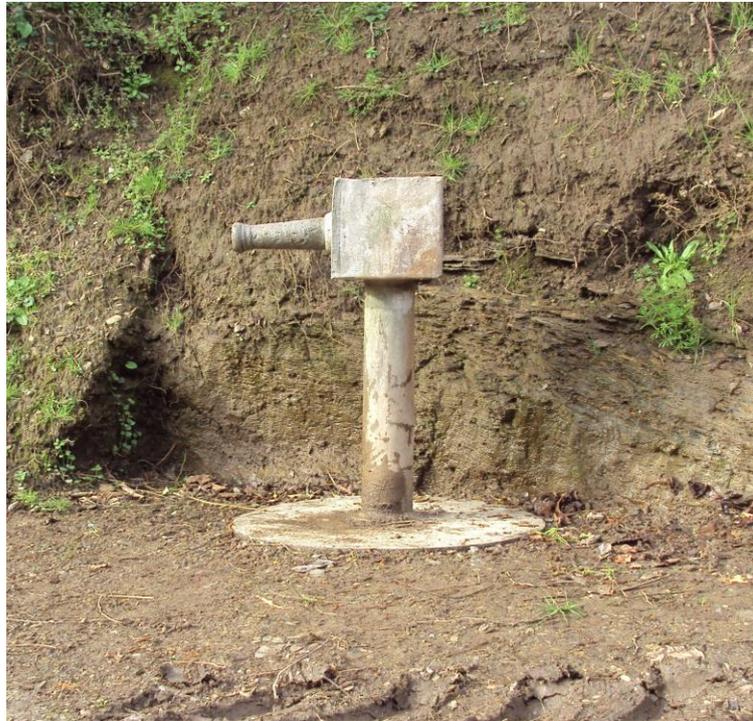
The arrival of early spring 2019 provided the opportunity to finish the project. The first job was to bend the Head of the Well back to a 90 degree angle with the Barrel. At some point pressure had been applied to the Nose which resulted in a 10 degree drop and it had partially split away from the Barrel edge. Old cast Lead can be tricky to rejoin I looked for some advice / expertise and found it again on the Village Pumps web page.

Godfrey Holter had taken it upon himself to restore the old pump in Treburley, Cornwall, which had also fallen into disuse with the coming of the water mains in 1953. It looked very similar to the our Beara Well Lead parts so advice was sought. Godfrey advised NOT to attempt a weld as the old cast Lead melting point could be quite unpredictable and I could lose the lot. I followed his advice to create a long handled levering jig from wood to put upward pressure on the lowered edge of the Head until it came perpendicular with the Barrel. All went well and some metal loaded 2 part epoxy was used to seal what remained of the crack between the Head and Barrel. This made the Head watertight.

A new plinth was created using hardcore and concrete placed in a mould circling the Pump (about 1 metre in diameter) made from galvanised steel which was left in-place. Before the concrete set, the pump was pushed down firmly onto the surface on the concrete and set-to-vertical using wood stays and left to settle in place as the concrete set.
