The Well at Beara in Devon:

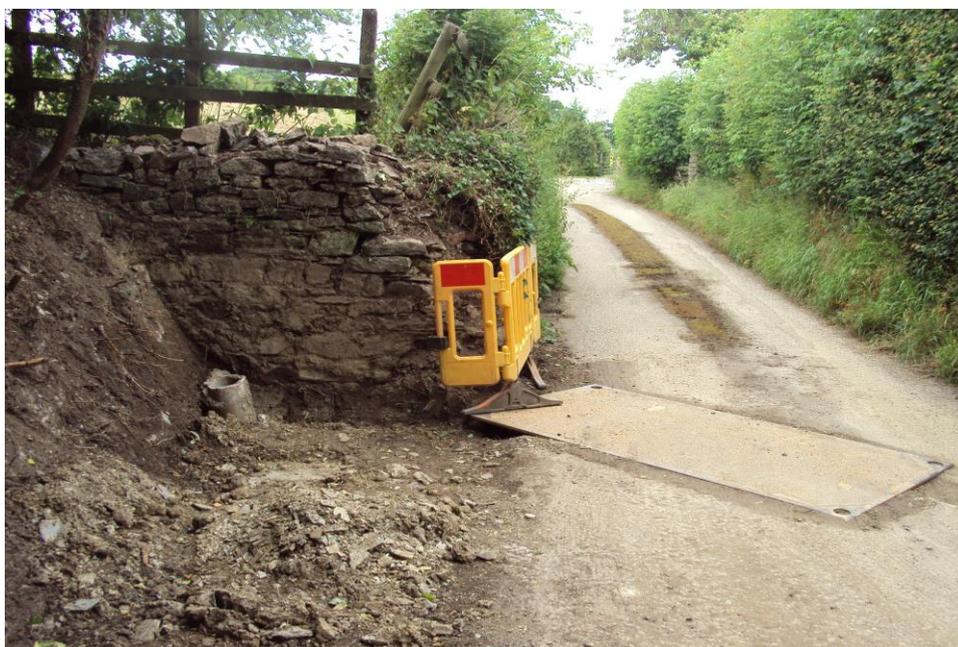
Around this time some home projects took precedence for a couple of months. During that time it was decided (by the Water Company) to install a new water main to the hamlet down from the upper road about 100 meters away. Part of this process was to dig under the lay-by's stone wall, about 3 meters deep, from inside the adjacent field. This was an added bonus for me in-that they had to clear away much of the soil build-up alongside the stone wall. During this clearing process they uncovered a very large slate slab, about 2 x 2 meters square (as far as we could determine) which returned a hollow sound when it was hit with a hammer. After a strong cuppa and in lieu of a more scientific explanation, we decided this was a natural chamber that the Well pipe was connecting into. However, why the Well was 2 meters away to its left of its supply was, and still is, a head-scratcher.

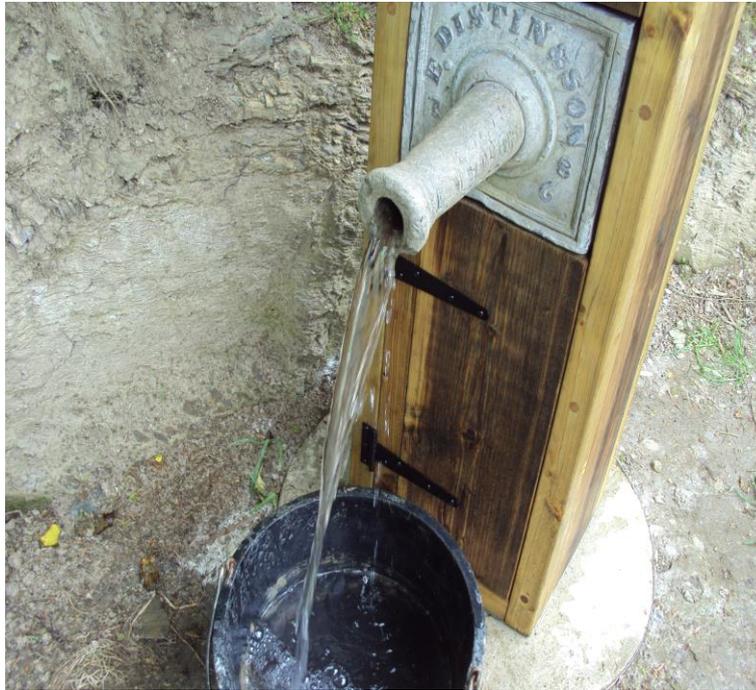
It took 2 to 3 days of interval pumping (about 4 times a day) to finally arrive at clear water. After priming, the first 2 buckets ran a little hazy but from that point onwards the water ran clear, cold and sweet. While there are still issues to resolve around the need to prime the Well, its water is being used daily to water greenhouse plants only, which are thriving very nicely on it. This usage will help to evaluate the duration of the water in the Well over the next few months to see how sustainable the supply is during the dryer months of the summer. The water will be tested at some point and the handle secured to prevent its use by the curious.

The Bucket and Rod was re-assembled to the Handle and the Frame was mounted around the Well Head and secured to the plinth with anchor bolts. Before using the pump handle the Well needed priming with a couple of litres of water being poured into the Head and the Handle was finally used to good effect. This was the icing on the cake.
