Restoration of lead hand pump to rear of a property near Malton North Yorkshire.

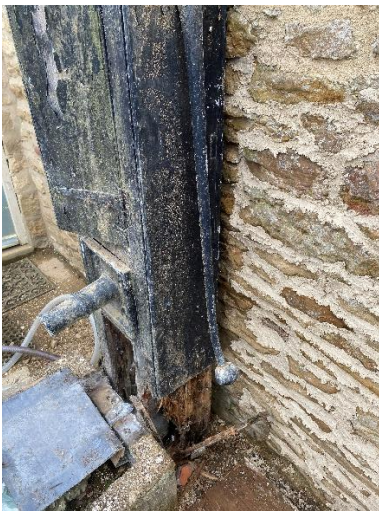
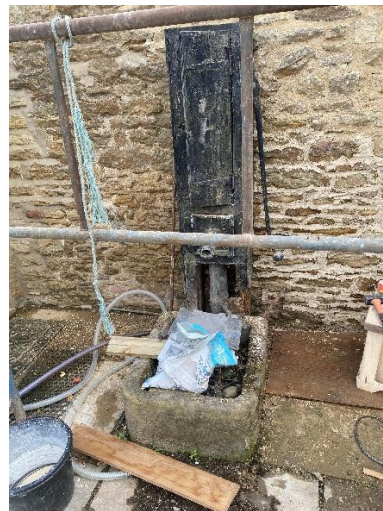
The pump sits to the rear of a property now privately owned which was originally a Castle Howard Estate property. It would have been the water supply to the house before mains water came to the village. It sits over a well which is approx. 30 ft deep with clear water about 8 ft from the surface. The wooden case of the pump was looking a bit sorry for itself and since the wall behind it was to be repointed in lime mortar I decided to take the case down for restoration. It looks to have previous restoration done – with new pieces spliced in at the bottom which have subsequently rotted out.

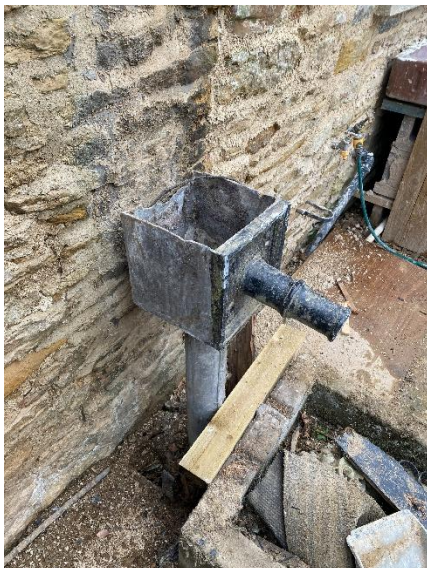
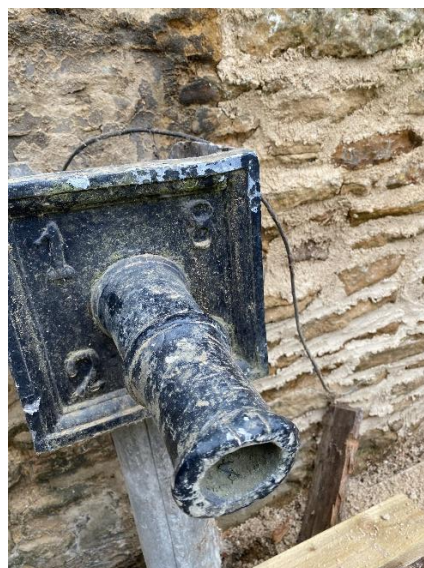
The case was removed leaving the lead pump in situ. The hopper is dated 1820

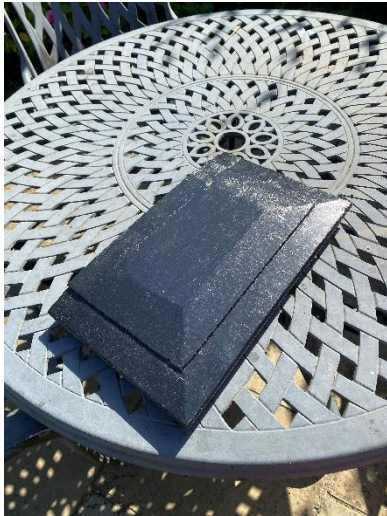
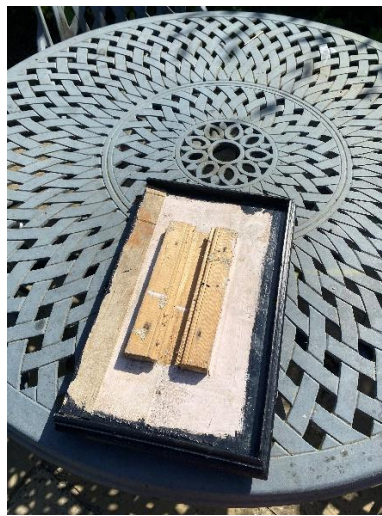
The lid of the case appeared to be a relatively modern replacement – this pump has been restored before. Some rot had set in along the back edge so a new piece was spliced in and a moulding added to act as a drip – hopefully to stop water tracking back under the lid and causing rot in the future.

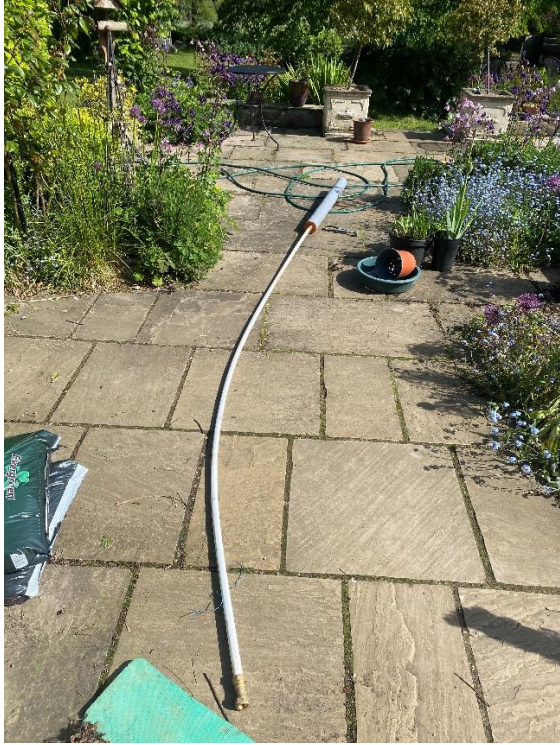
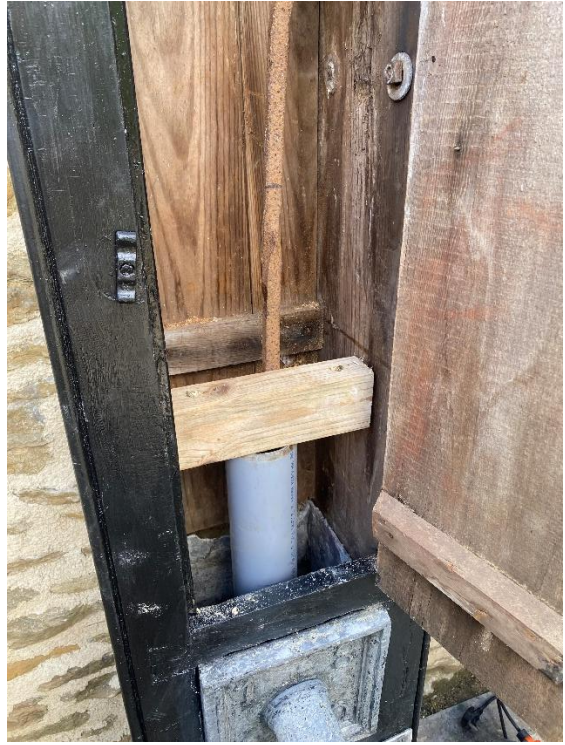
I had attempted to make the pump functional a few years ago – with partial success – a new plunger valve was turned – the old one having rotted away – and a basic foot valve made from a dogs kong toy sitting in the bottom of the barrel. It sort of worked but would not hold prime for more than a few minutes – also the lead barrel was quite severely worn on one side after probably 150 years of use. So I decided to reline the barrel and fit a proper foot valve. I wanted to do this in such a way as to have zero impact on the historical fabric of the pump and to be entirely reversible.

I used a length of 82mm OD soil pipe which was a nice fit into the lead barrel – a length of 22mm plastic pipe with a 22mm non return valve at the bottom acts as a suction pipe and fits inside the existing lead riser pipe – the whole lot can just be lowered into position and can be easily removed for servicing later on. To hold it in place I used a wooden cross member so no fixings are required to the existing lead hopper.

The remains of the existing bottom clack valve have been left in the hopper for future generations.
